Document Number: 4806-00041A

This document applies to the below application	ocument applies to the below application type.		
Chassis Make	Isuzu		
Chassis Model	NPR		
Chassis Year	2024 - 2025		
ZeroRPM Product	IMPAC		
	PDM v01.01.03		
ZeroRPM Software	PLC v6.00.00		
	HMI v06.01.02

SECTION 1: DESCRIPTION OF DOCUMENT

SECTION 2: TROUBLESHOOTING SCENARIOS

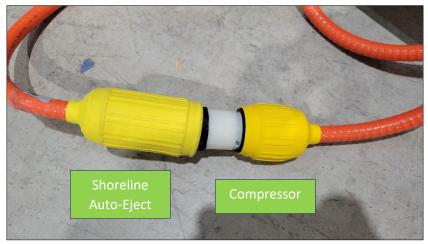
- 2.1. Air Compressor Does Not Start
 - 1. Before proceeding, verify the following:
 - a. Is the truck in Equipment Activation mode?
 - b. Did you press and hold the Air Compressor Request switch for one second?
 - c. Is the air compressor temperature 45°F or higher?
 - d. Is the 120V air compressor breaker in the ON position (not tripped) **and** does the red LED turn on when the Air Compressor Request switch is selected?
 - i. If the LED flashes, then continue to Step 2.
 - ii. If the LED remains off, then contact ZeroRPM technical support at 1-855-937-6776.
 - iii. If the LED is solid red and the breaker is not tripped, then continue to Step 2c.
 - 2. Disconnect shore power and the air compressor from the PDM.
 - a. Bypass the IMPAC system by connecting the air compressor plug to the Shoreline Auto-Eject receptacle (pictured below).

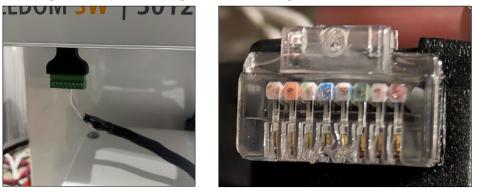
a. If AC voltage is not displayed, then ensure the RJ45 data connector on the bottom of the inverter (pictured below, left) is properly seated and undamaged. The image below and to the right shows a damaged RJ45 connector.

- ii. If the RJ45 connector is undamaged but is seated improperly, then remove it and reinsert it to ensure it is fully engaged.
- iii. If the RJ45 connector is damaged, then the body harness must be replaced; see the IMPAC Maintenance and Replacement Parts Guide (4806-00042) for details.

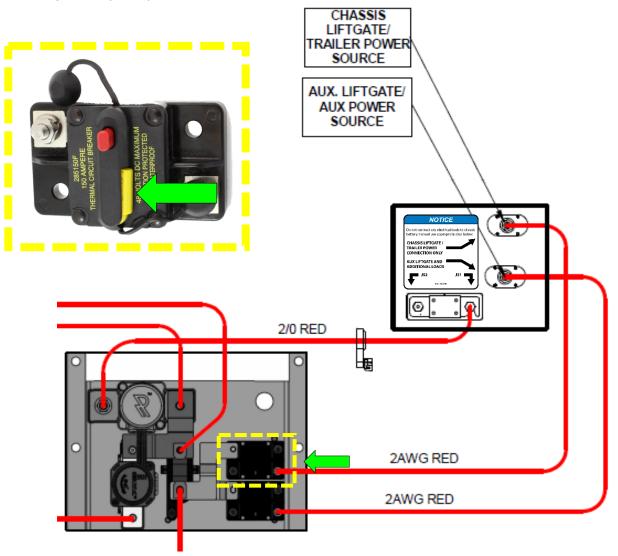
- 1. Before proceeding, verify the following:
 - a. Is the truck running **or** in Equipment Activation mode? This check ensures the battery voltage is high enough to operate the liftgate.
- 2. If the liftgate/trailer power source does not operate, **then** verify the top stud on the junction plate (pictured below) reads 12VDC.

- a. **If** 12VDC is present on the stud, **then** reference the OEM liftgate documentation to determine how to proceed.
- b. **If** 12VDC is not present on the stud, **then** inspect the top breaker on the leadacid disconnect plate.
 - i. If the swing arm is open, then push it back in until you hear a click.
 - ii. If the swing arm is closed, then check for 12VDC on the right side of the breaker.
 - 1. If 12VDC is not present on the right side of the breaker, **then** check for voltage on the left side.
 - a. If voltage is not present on either side of the breaker;
 then contact ZeroRPM technical support at 1-855-937-6776.
 - b. If power is present on the left side but not the right, then the breaker must be replaced; see the IMPAC Maintenance and Replacement Parts Guide (4806-00042) for details.

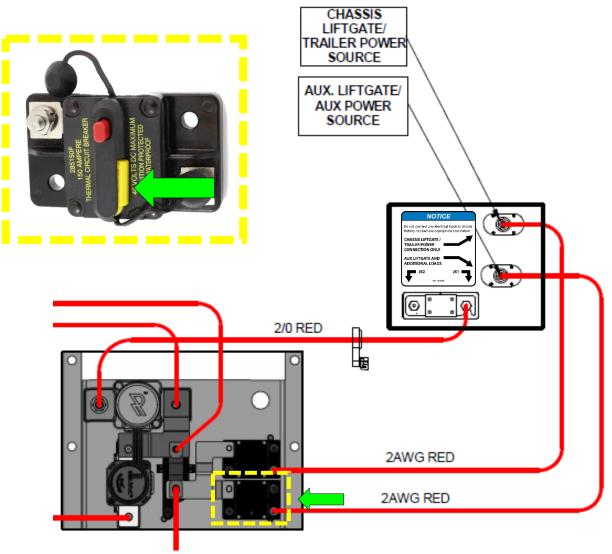
- 1. Before proceeding, verify the following:
 - a. Is the truck running **or** in Equipment Activation mode? This check ensures the battery voltage is high enough to operate the liftgate.
- 2. If the liftgate/trailer power source does not operate, **then** verify the top stud on the junction plate (pictured below) reads 12VDC.

- a. **If** 12VDC is present on the stud, **then** reference the OEM liftgate documentation to determine how to proceed.
- b. **If** 12VDC is not present on the stud, **then** inspect the bottom breaker on the lead-acid disconnect plate.
 - i. If the swing arm is open, then push it back in until you hear a click.
 - ii. If the swing arm is closed, then check for 12VDC on the right side of the breaker.
 - 1. If 12VDC is not present on the right side of the breaker, **then** check for voltage on the left side.
 - a. If voltage is not present on either side of the breaker, then contact ZeroRPM technical support at 1-855-937-6776.
 - b. If power is present on the left side but not the right, then the breaker must be replaced; see the IMPAC Maintenance and Replacement Parts Guide (4806-00042) for details.

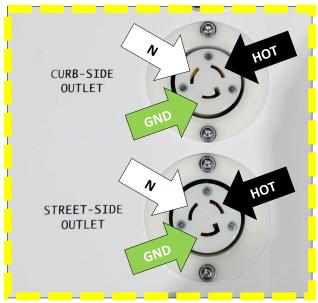
- 1. Before proceeding, verify the following:
 - a. Is the truck running, **or** in Equipment Activation mode, **or** connected to shore power?
- 2. Verify the corresponding curb-side/street-side breaker is in the ON position.
 - a. If the red LED on the GFCI is illuminated, **then** unplug all connections from it and press the reset button on the GFCI.
 - If the GFCI does not reset, then the curb-side/street-side harness must be replaced; see the IMPAC Maintenance and Replacement Parts Guide (4806-00042) for details.
 - b. **If** the green LED on the GFCI is illuminated, **then** measure for at least 110VAC at the plug.
 - i. If at least 110VAC is present, then the failure is with the device you are connecting.
 - ii. **If** 110VAC is not present, **then** measure for at least 110VAC at the corresponding receptacle on the PDM.

- If 110VAC is present at the receptacle on the PDM but not at the outlet, then the curb-side/street-side harness must be replaced; see the IMPAC Maintenance and Replacement Parts Guide (4806-00042) for details.
- 2. If voltage is not present at the PDM, then contact ZeroRPM technical support at 1-855-937-6776.

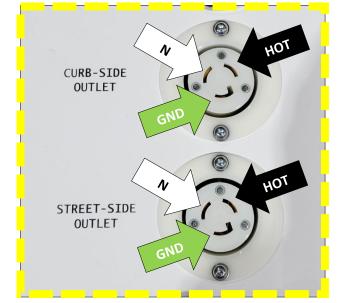
- c. If neither LED on the GFCI is illuminated, then measure for at least 110VAC at the plug.
 - i. **If** 110VAC is not present at the plug, **then** measure voltage at corresponding receptacle on the PDM.

- If voltage is present at the PDM, then the curb-side/street-side harness must be replaced; see the IMPAC Maintenance and Replacement Parts Guide (4806-00042) for details.
- 2. If voltage is not present at the PDM, then contact ZeroRPM technical support at 1-855-937-6776.
